# Manhole Inspection Summary

Manhole # S43UU\_007MH

**Location** Address: **1609 28H ST**

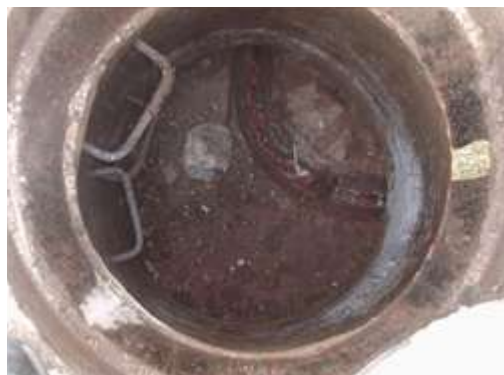
Top View

Corroded steps. Evidence of surcharge - Bench debris. Channel debris.

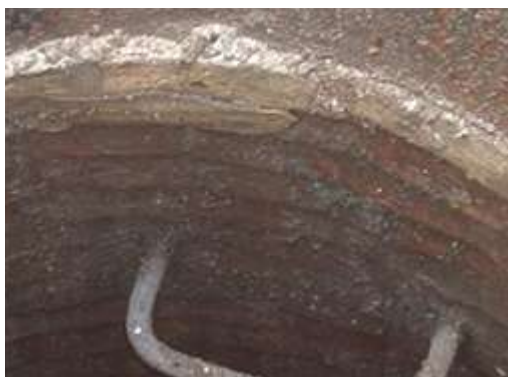
Defect

Frame leaks. Adjustment deterioration and infiltration.

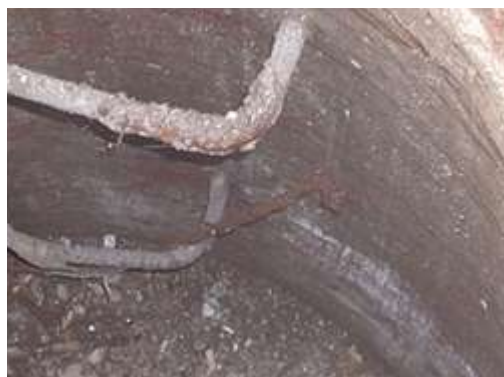
Defect

Corbel infiltration.

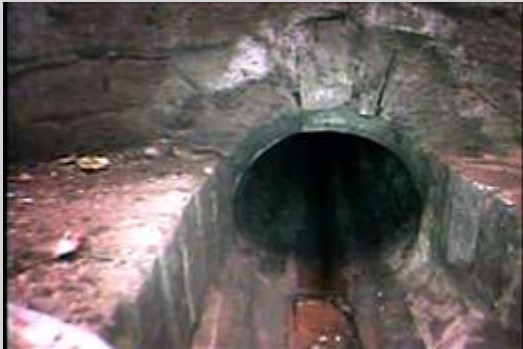
### 8 in. Circular Gravity Sewer Pipe Out @ 12 O'Clock

Invert Depth: **7.25** (ft.) Flow Characteristics: **Slow**

Infiltration: **None** Pipe Seal Cond: **Unknown**

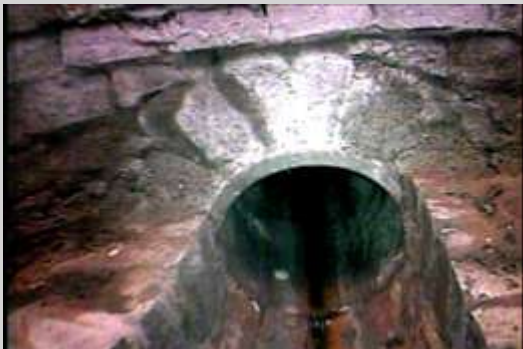
### 8 in. Circular Gravity Sewer Pipe In @ 3 O'Clock

Invert Depth: **7.03** (ft.) Flow Characteristics: **Slow**

Infiltration: **None** Pipe Seal Cond: **Unknown**
